Environmental Resources Report

Enon Solar Farm, LLC

275 Enon Road Fredericksburg, Stafford County, Virginia Headwater Project #202145A

December 23, 2021 revised April 19, 2022

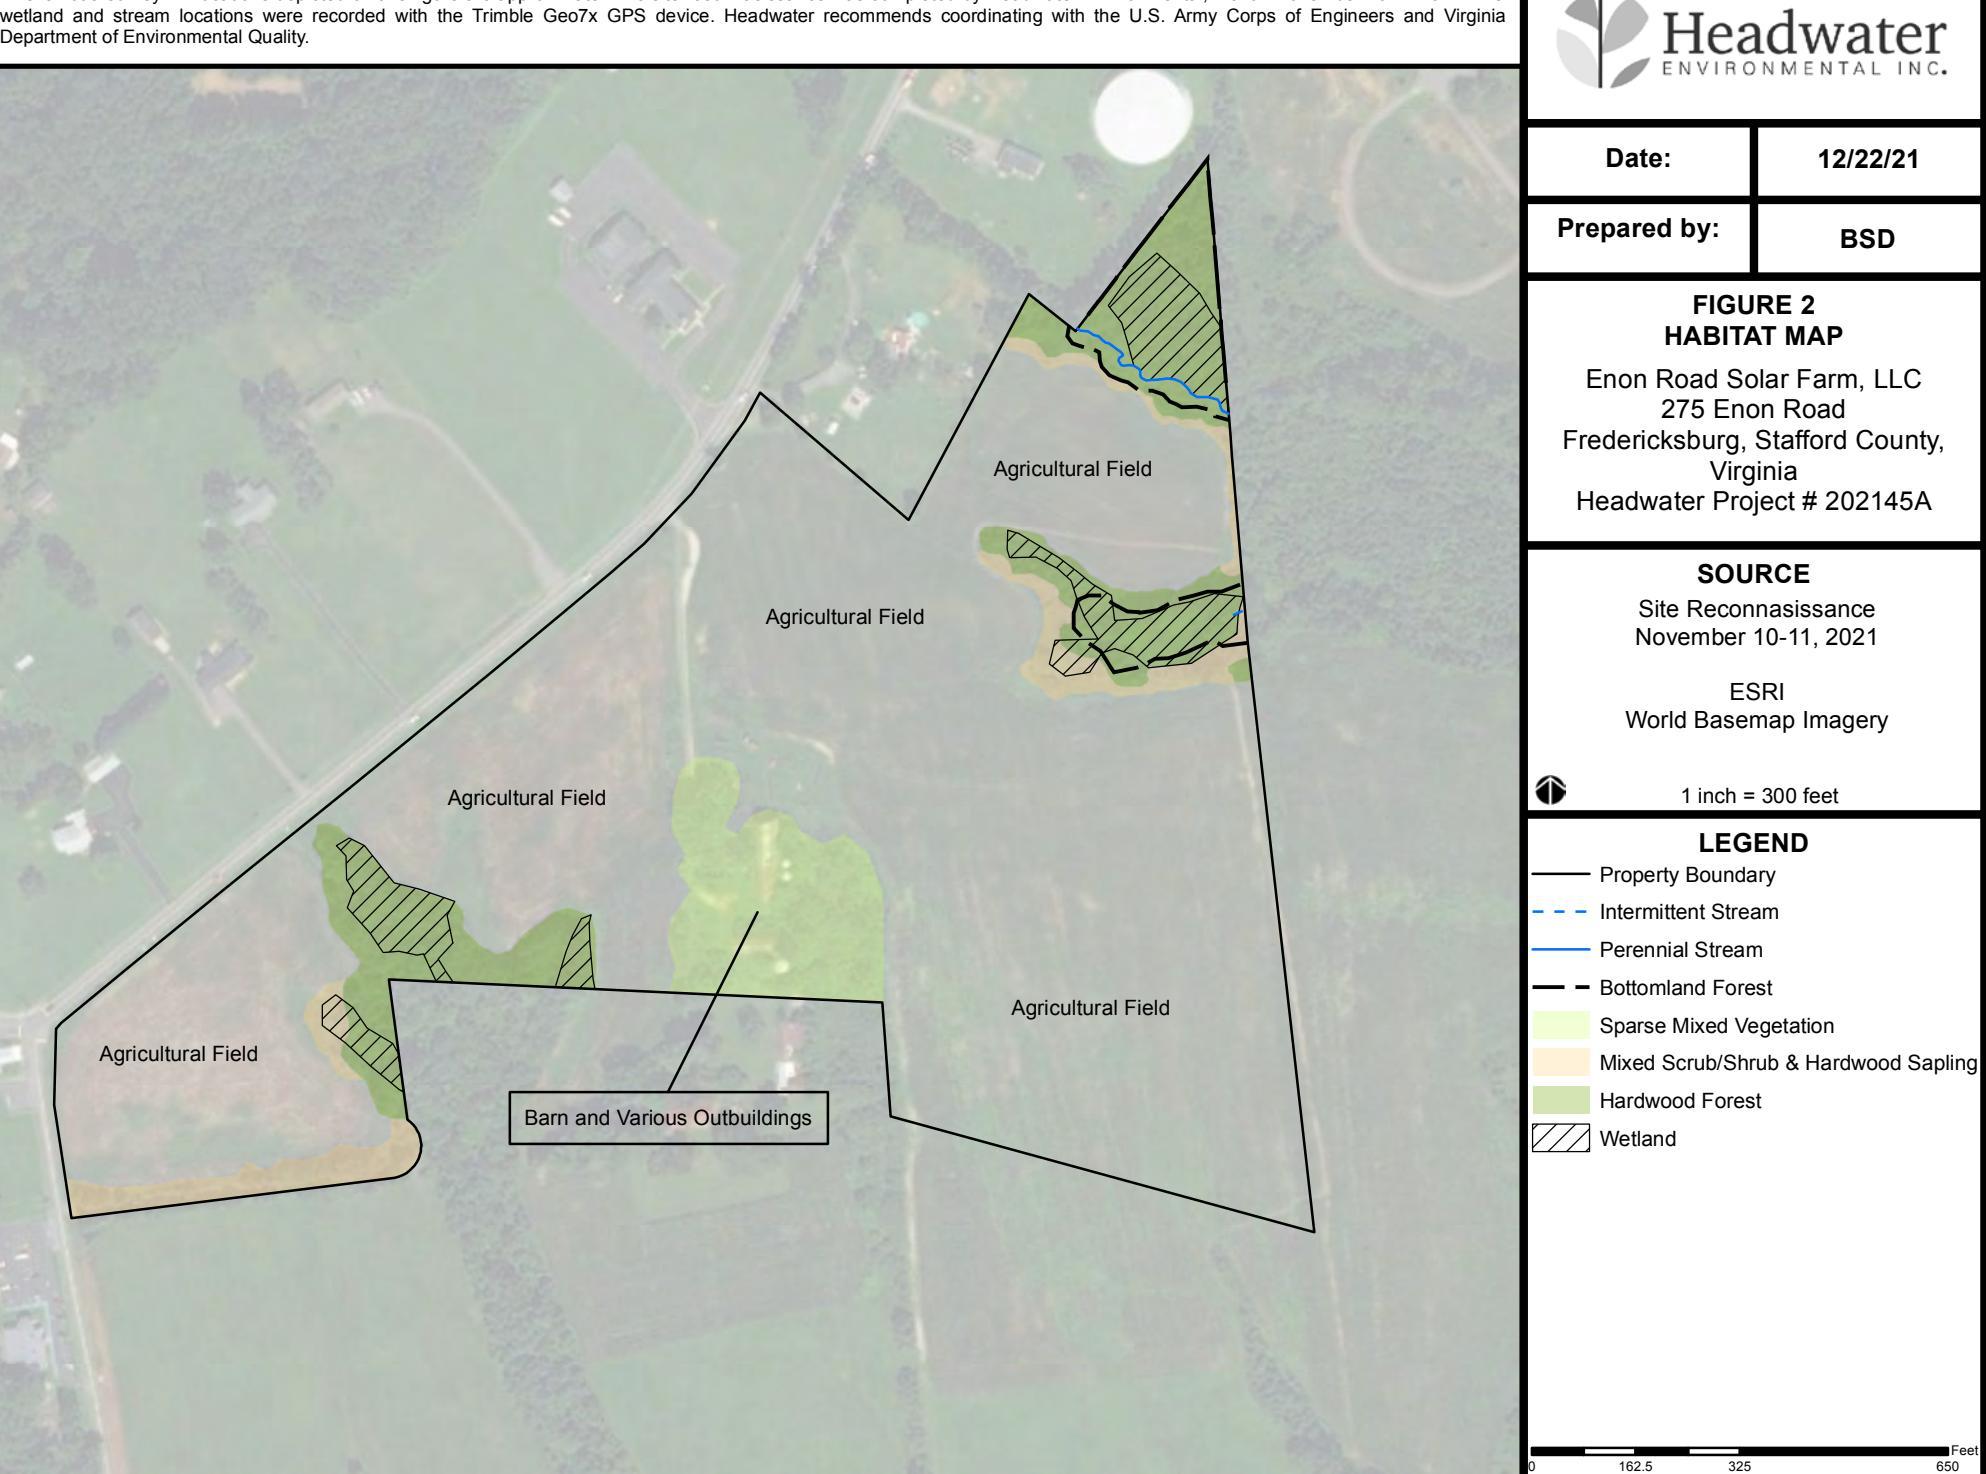
This is not a survey. All locations depicted on this figure are approximate. This site reconnasissance was completed by Headwater Environmental, Inc. on November 10-11-2021. The wetland and stream locations were recorded with the Trimble Geo7x GPS device. Headwater recommends coordinating with the U.S. Army Corps of Engineers and Virginia Department of Environmental Quality.

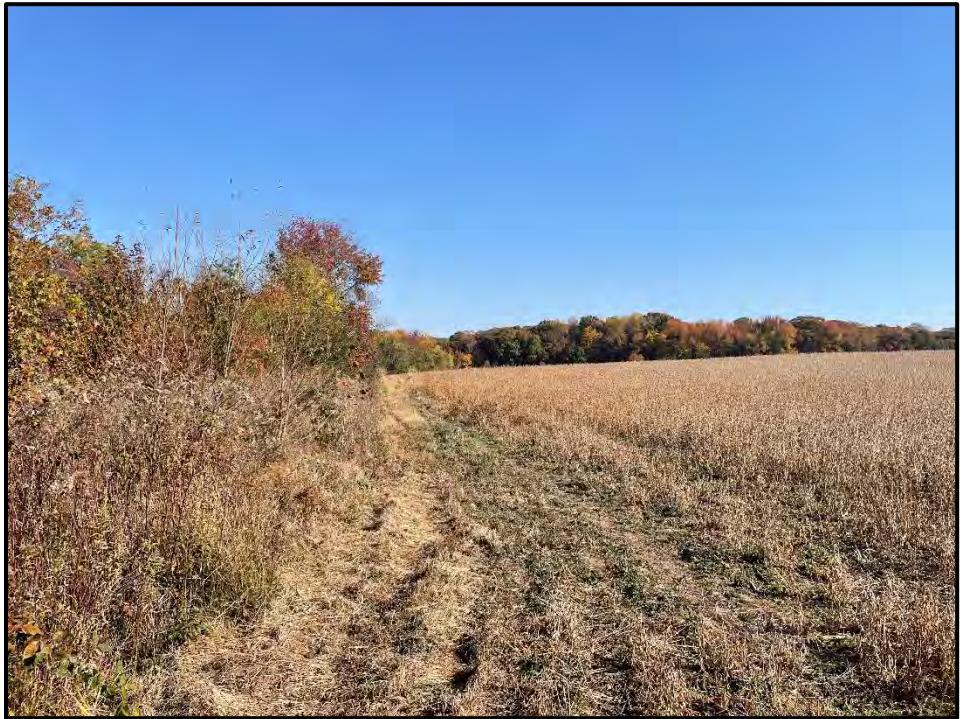
Photograph 1: Agricultural fields throughout the site.

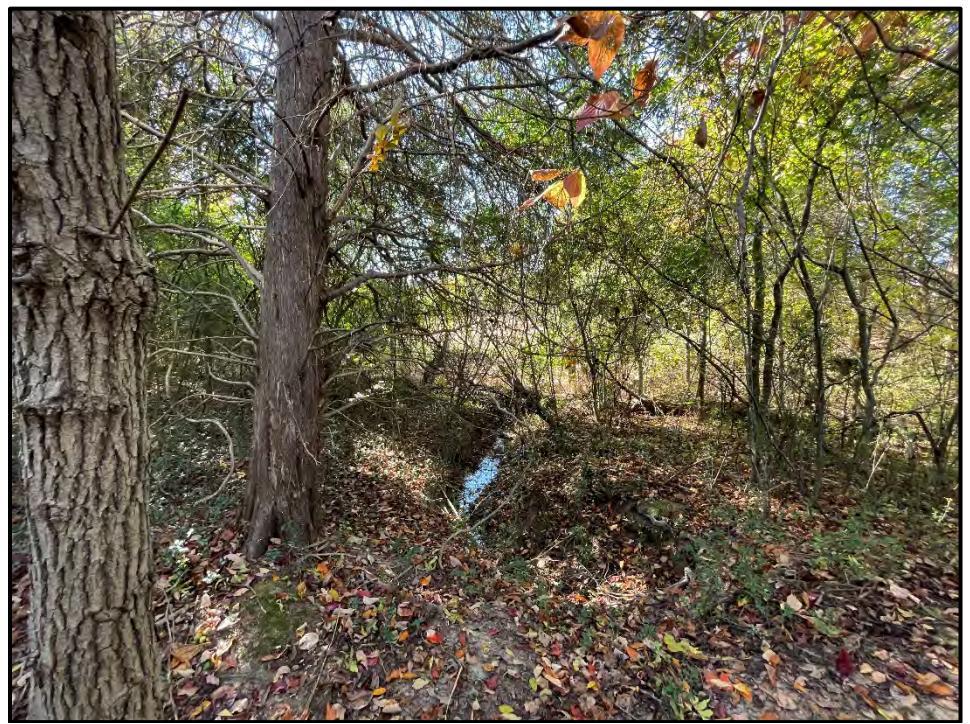
Headwater delineated three (3) wetlands and one perennial stream within the site. Wetland Area A and B are located on the northeast portion of the site. Wetland A is abutting and adjacent to an off-site perennial stream. Wetland B is abutting Stream B, which is also perennial. Wetland C is located on the central-western portion of the site. Wetland C is abutting an intermittent stream. Refer to Figure 2 in Appendix A for a depiction of the wetlands and streams.

Photograph 2: Stream and wetland on the northeastern portion of the site.

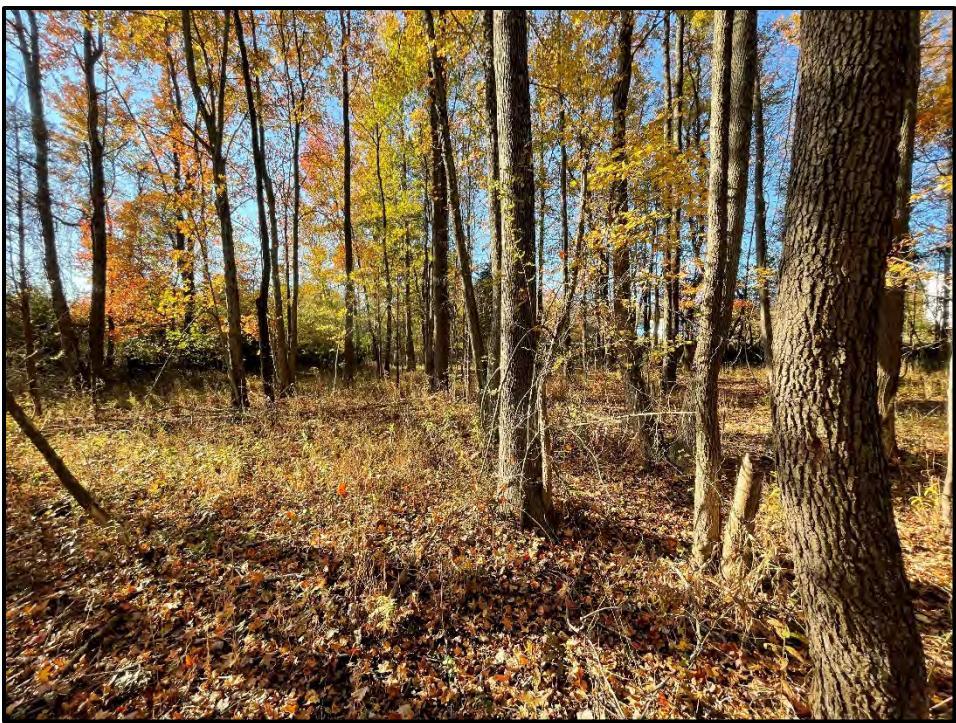
Photograph 3: Hardwood vegetation and wetland located along the southern property boundary.

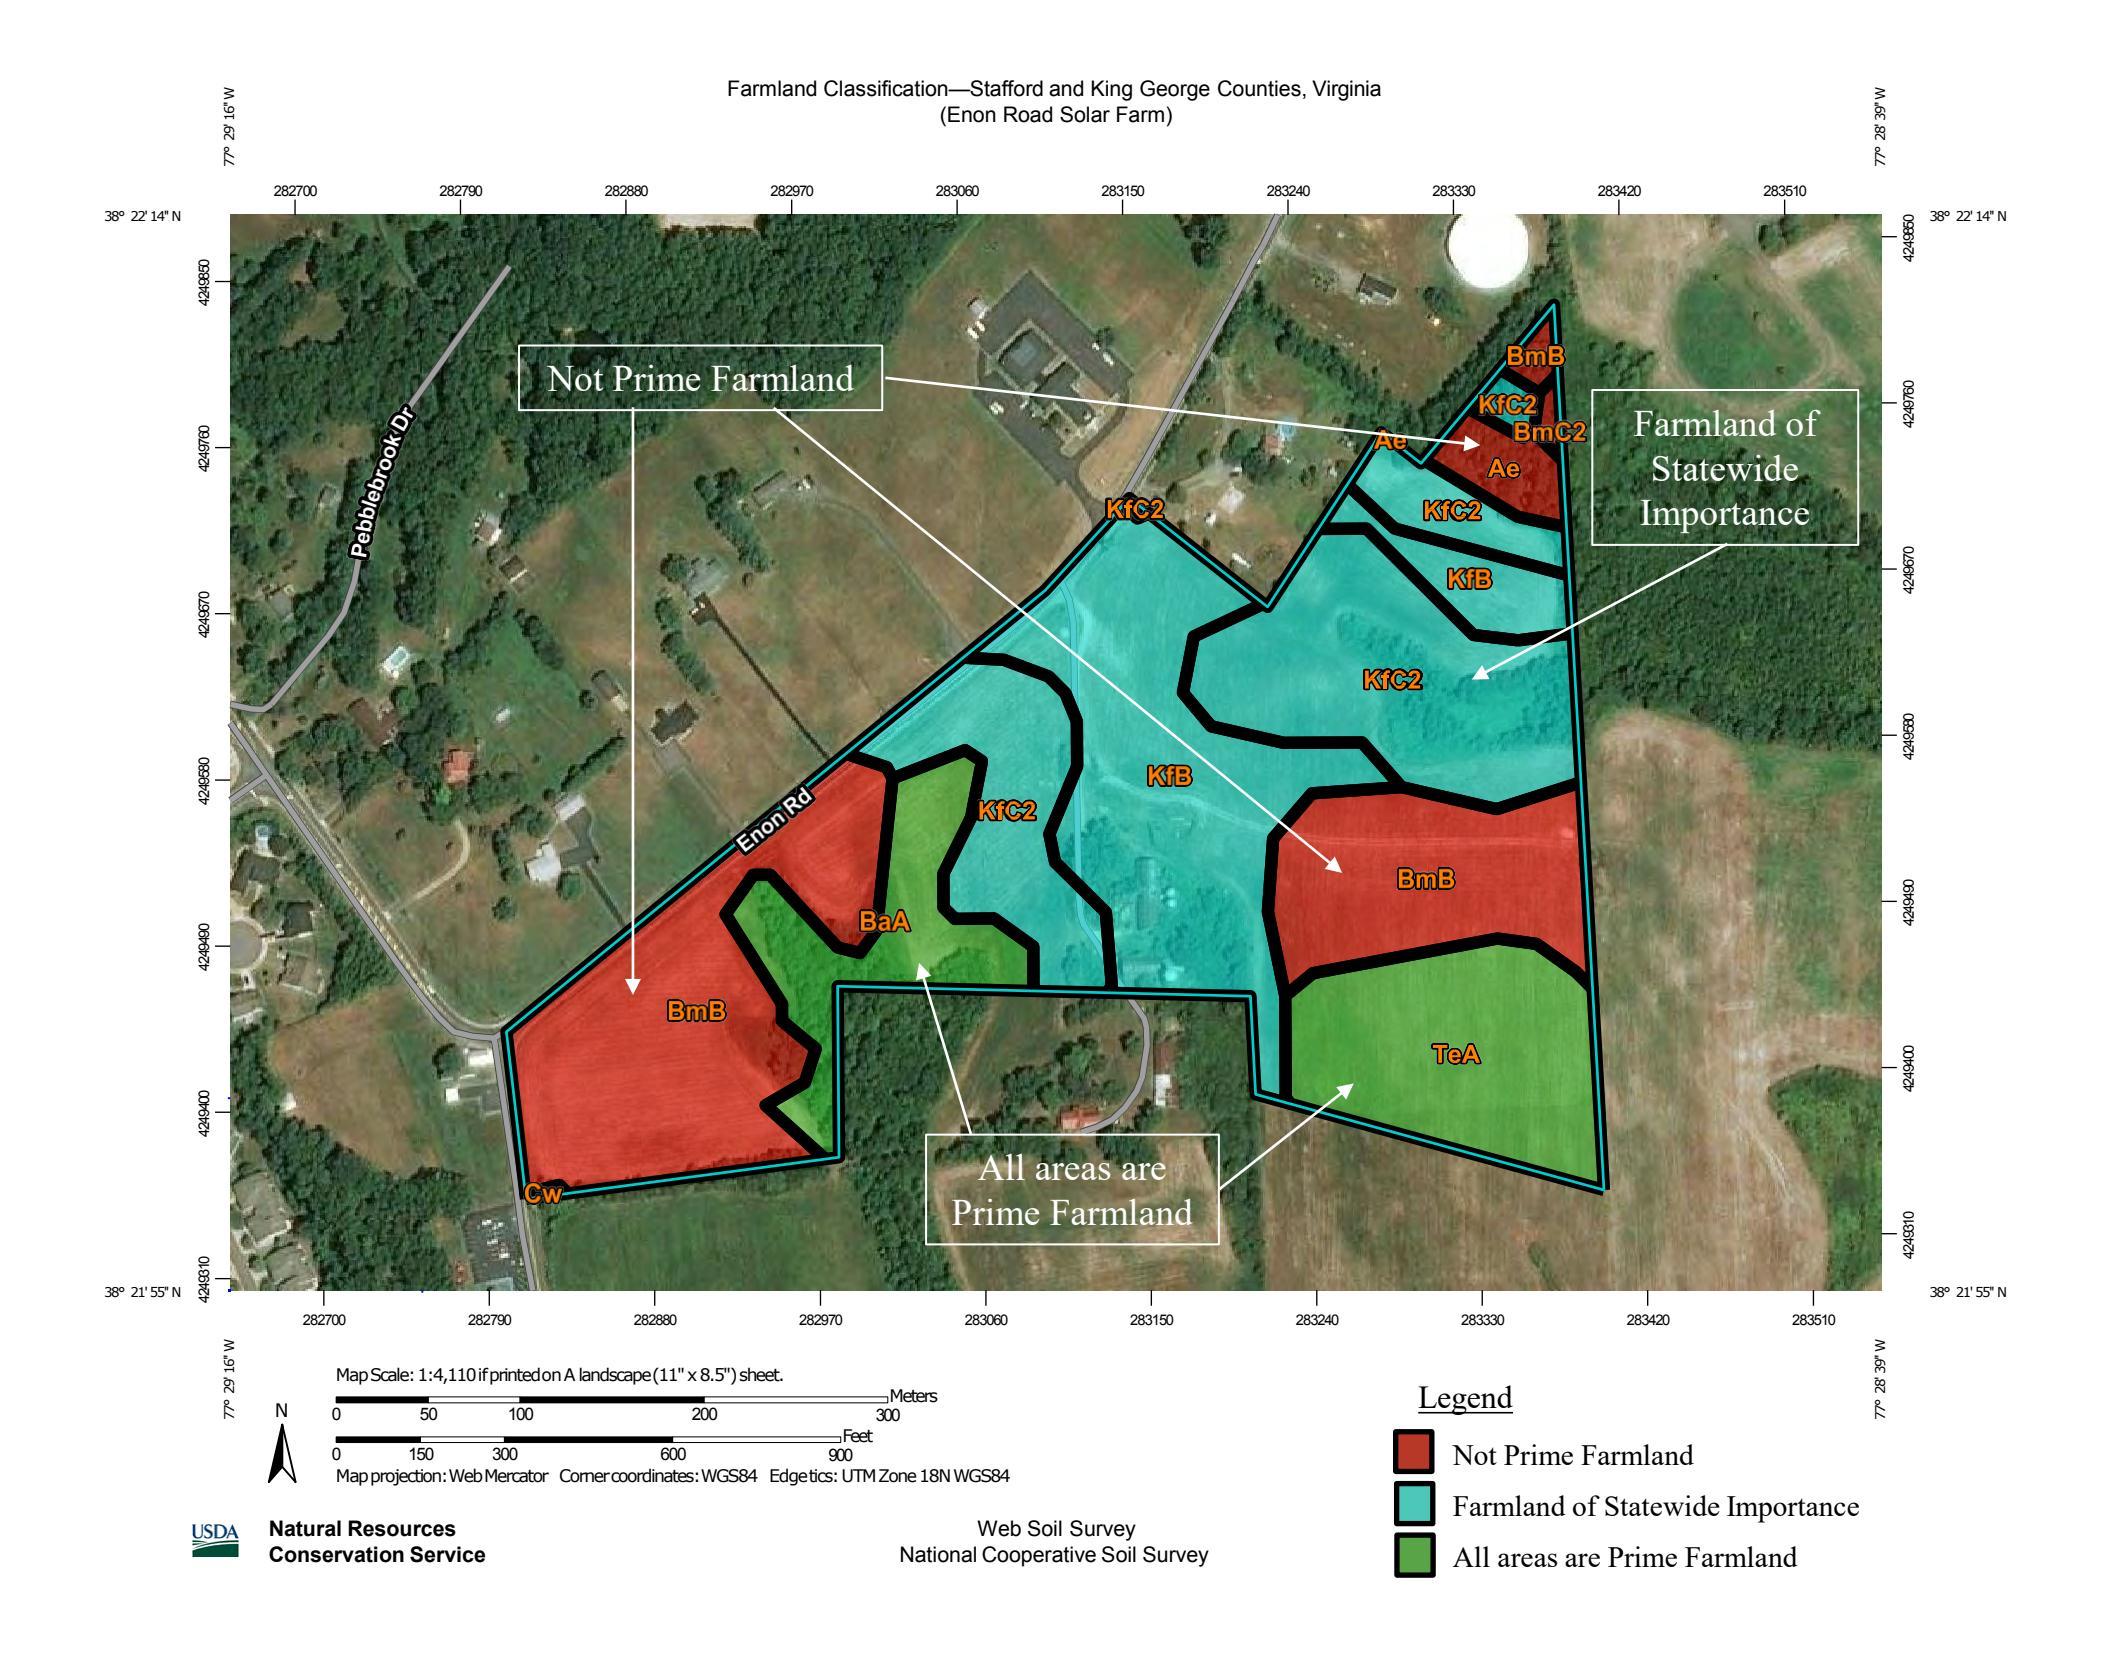
Farmland Classification

Map unit symbol	Map unit name	Rating	Acres in AOI	Percent of AOI		
Ae	Alluvial land, wet	Not prime farmland	0.7	2.0%		
BaA	Bertie very fine sandy loam, 0 to 3 percent slopes	All areas are prime farmland	2.9	8.2%		
BmB	Bourne fine sandy loam, 2 to 6 percent slopes	Not prime farmland	10.1	29.0%		
BmC2	Bourne fine sandy loam, 6 to 10 percent slopes, eroded	Not prime farmland	0.1	0.3%		
Cw	Cut and fill land	Not prime farmland	0.0	0.1%		
KfB	Kempsville fine sandy loam, gravelly substratum, 2 to 6 percent slopes	Farmland of statewide importance	7.9	22.6%		
KfC2	Kempsville fine sandy loam, gravelly substratum, 6 to 10 percent slopes, eroded	Farmland of statewide importance	8.9	25.6%		
ТеА	Tetotum fine sandy loam, 0 to 2 percent slopes	All areas are prime farmland	4.3	12.2%		
Totals for Area of Inter	rest	34.9	100.0%

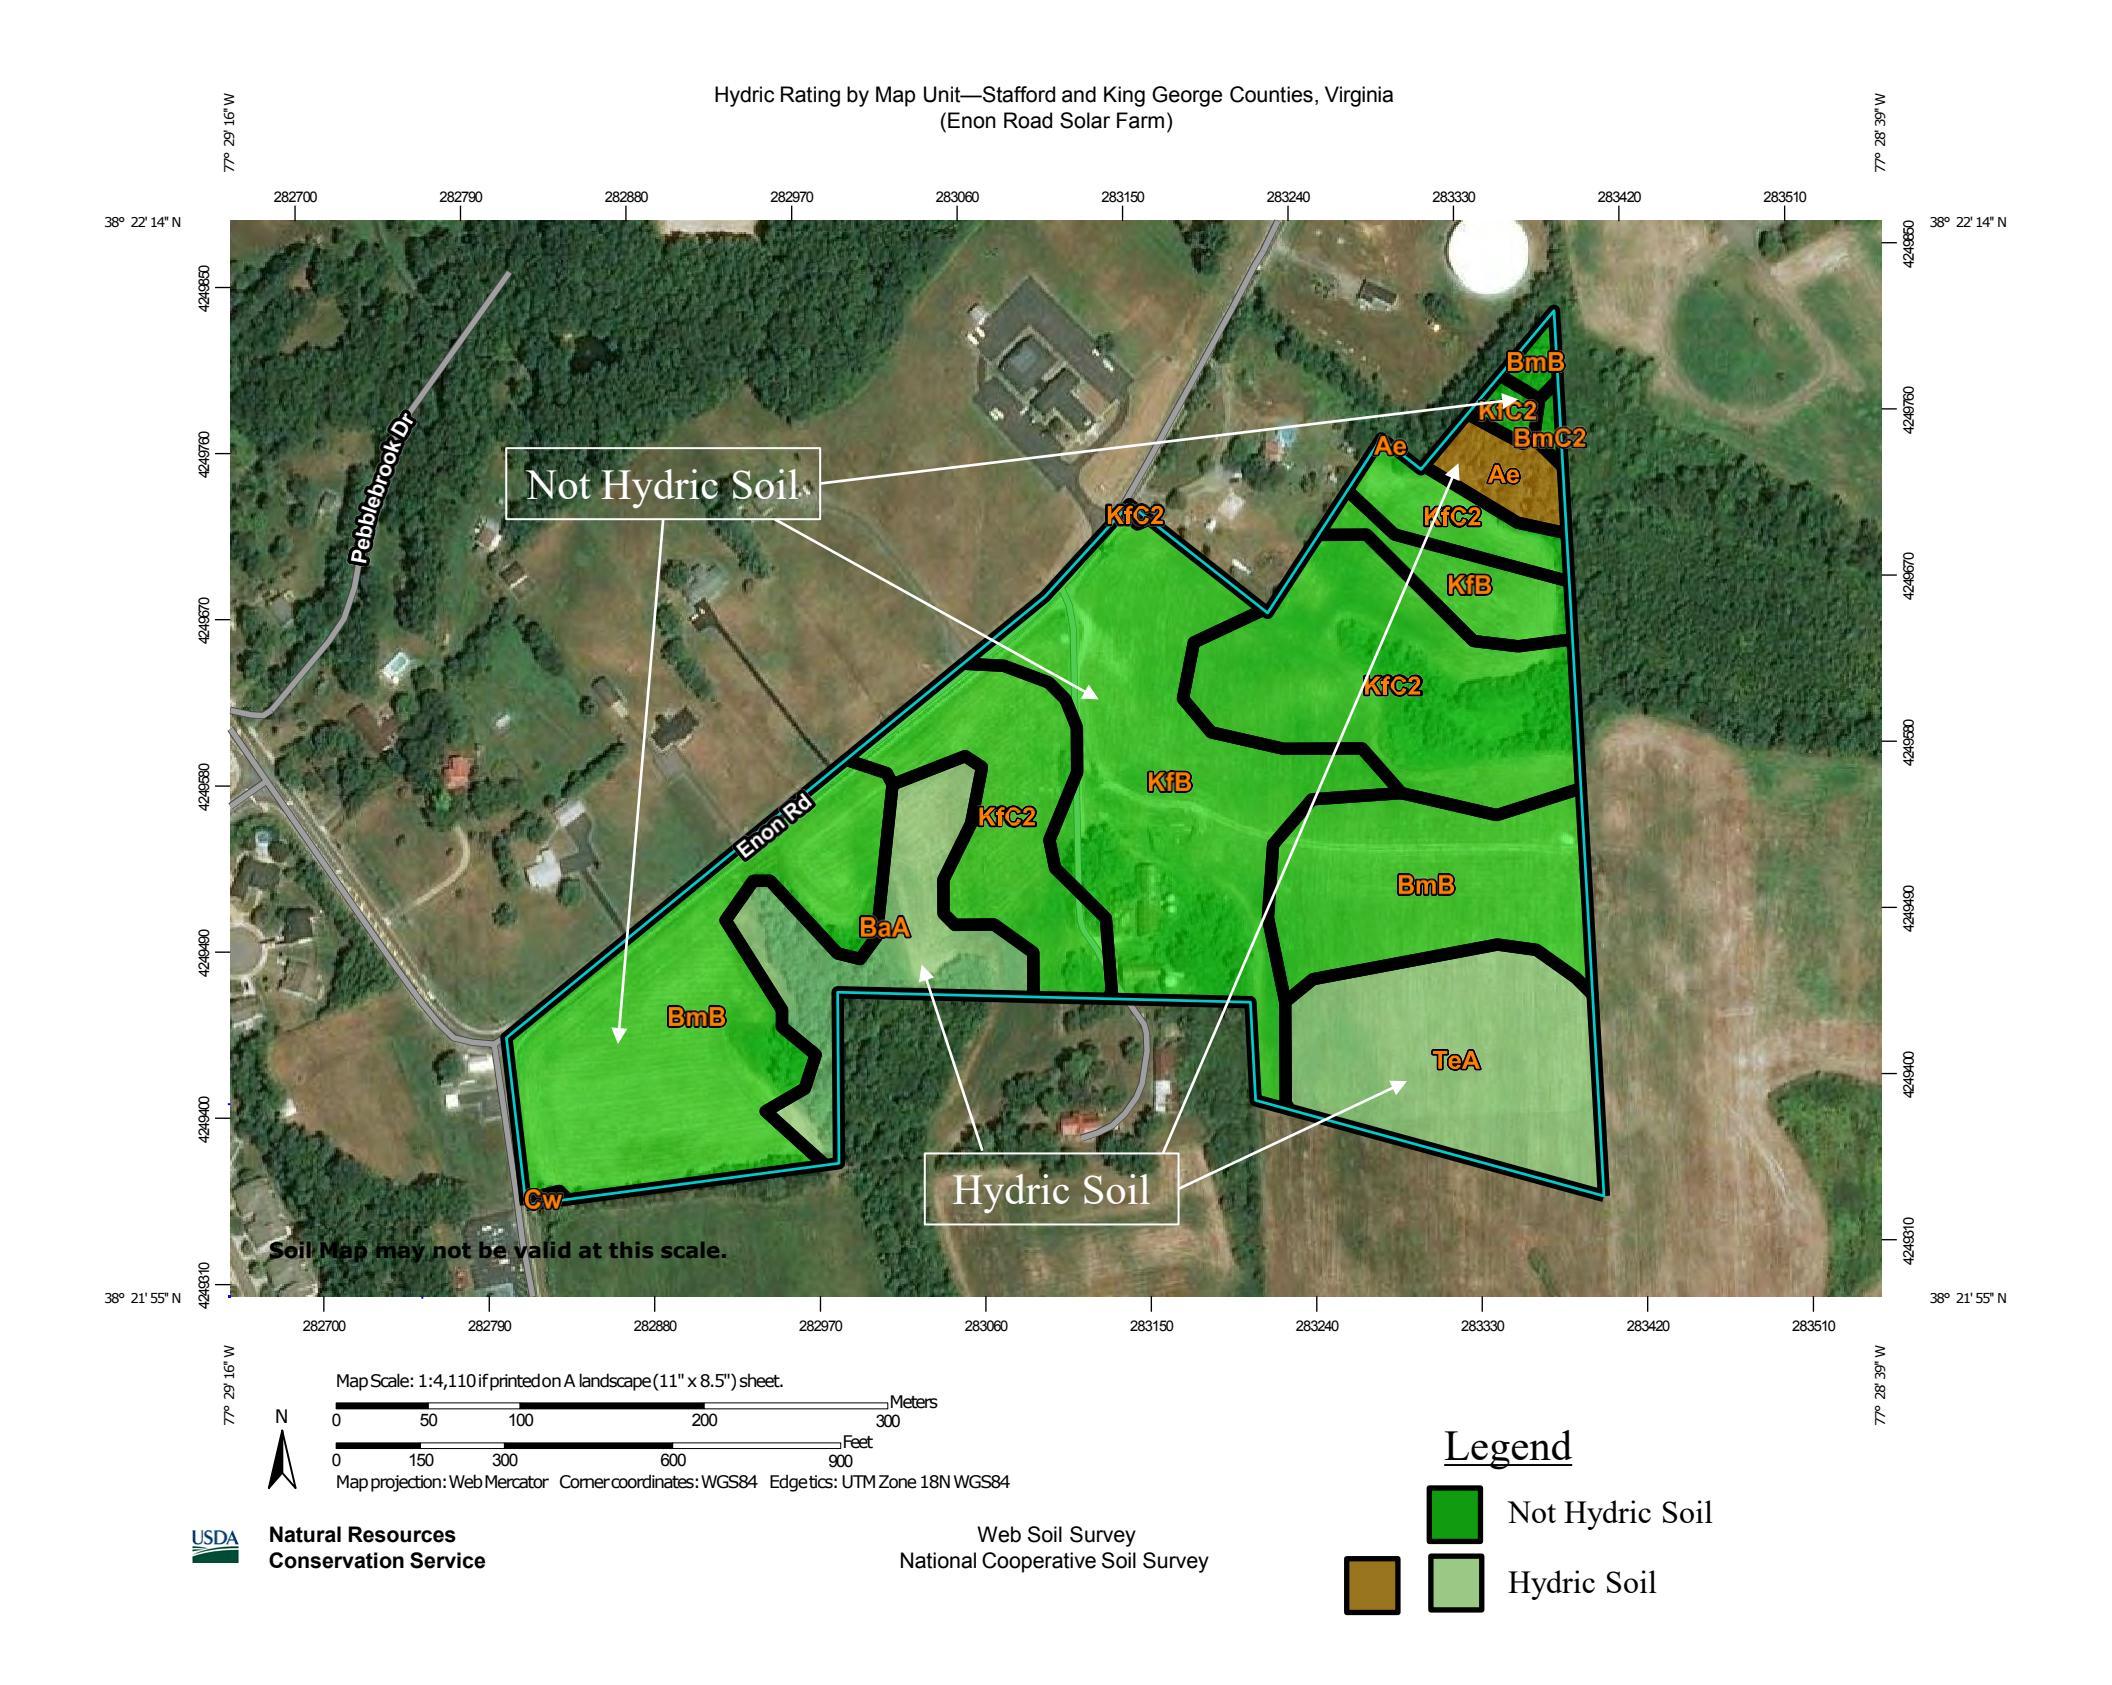
Hydric Rating by Map Unit

Map unit symbol	Map unit name	Rating	Acres in AOI	Percent of AOI		
Ae	Alluvial land, wet	85	0.7	2.0%		
BaA	Bertie very fine sandy loam, 0 to 3 percent slopes	9	2.9	8.2%		
BmB	Bourne fine sandy loam, 2 to 6 percent slopes	0	10.1	29.0%		
BmC2	Bourne fine sandy loam, 6 to 10 percent slopes, eroded	0	0.1	0.3%		
Cw	Cut and fill land	0	0.0	0.1%		
KfB	Kempsville fine sandy loam, gravelly substratum, 2 to 6 percent slopes	0	7.9	22.6%		
KfC2	Kempsville fine sandy loam, gravelly substratum, 6 to 10 percent slopes, eroded	0	8.9	25.6%		
ТеА	Tetotum fine sandy loam, 0 to 2 percent slopes	9	4.3	12.2%		
Totals for Area of Interest			34.9	100.0%
